Figure 4-1. Decision diagram for landfill waste characterization with contingent monitoring, capping, or excavation.

Figure 4-7. Locations of Site 300 soil and/or landfill waste remediation modules.

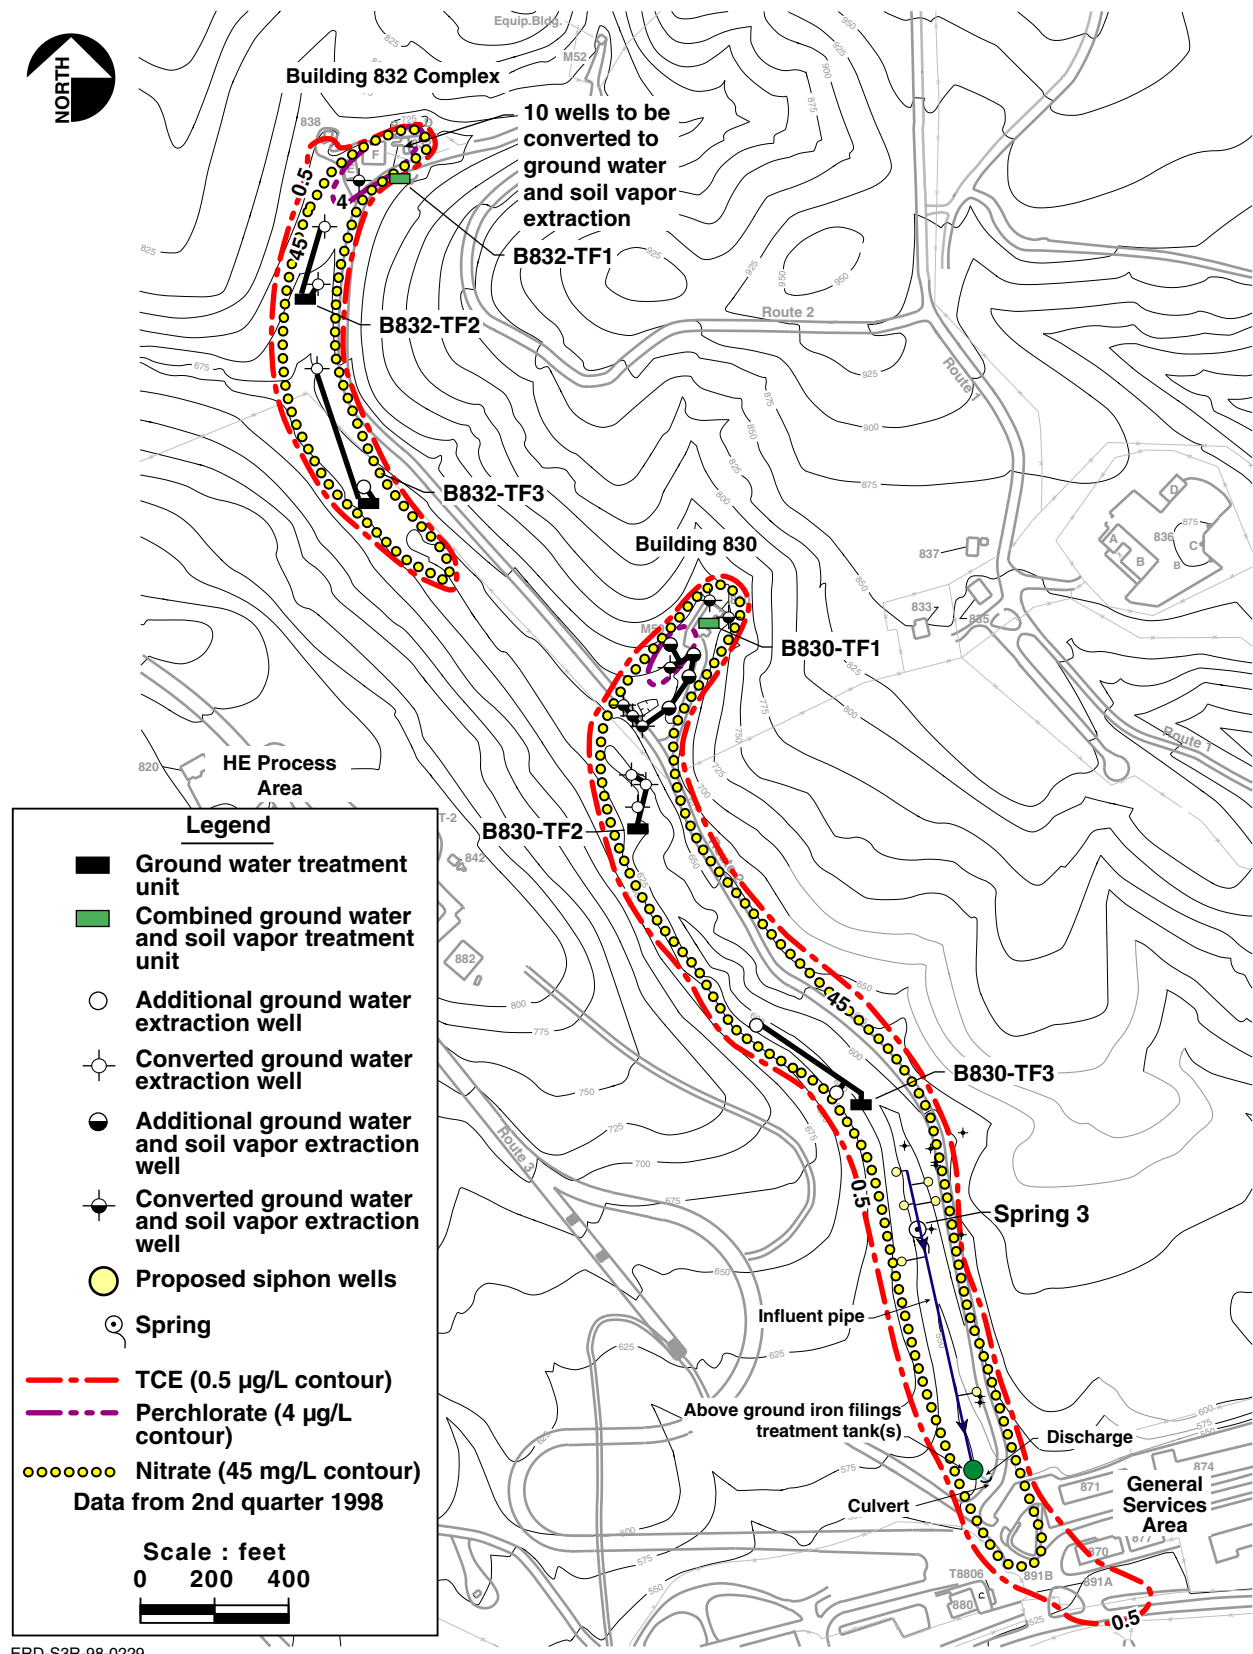
Figure 4-12. Locations of components of the Building 832 Canyon remediation modules, (OU7).

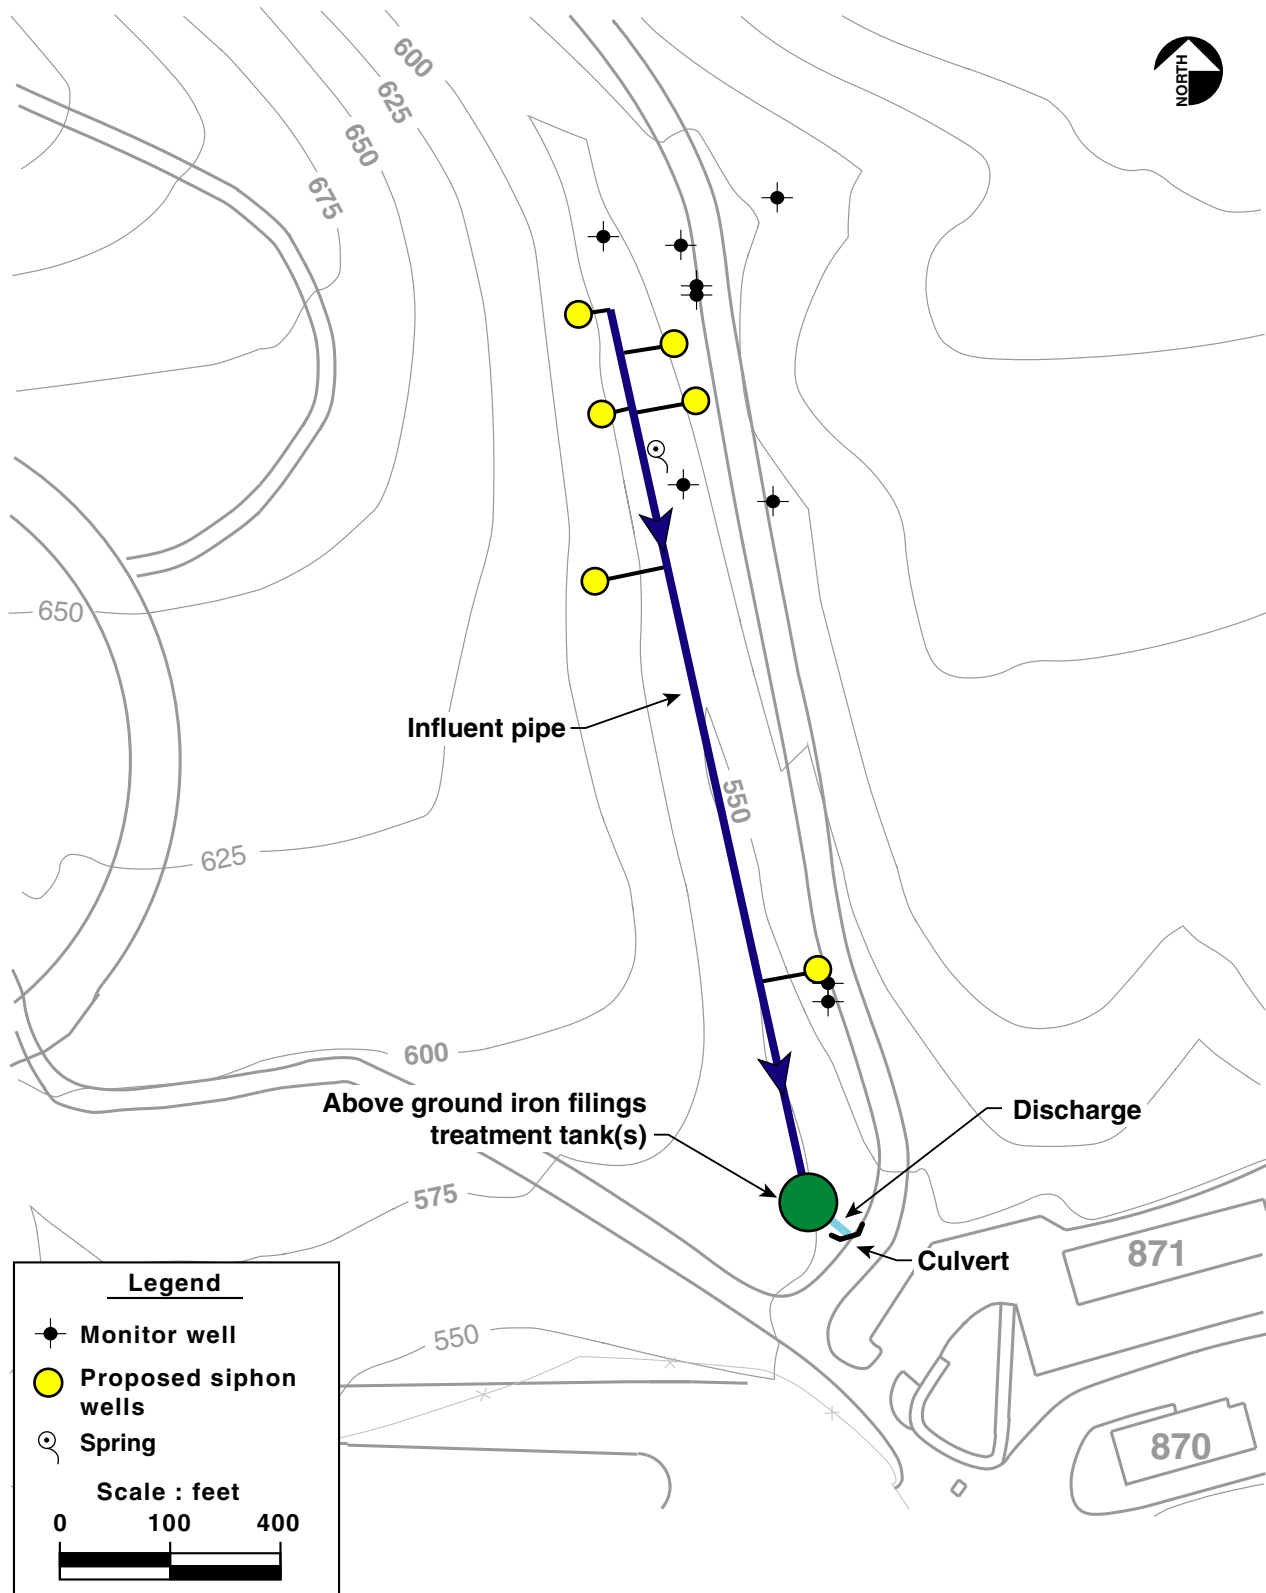
ERD-S3R-98-0289

Figure 4-13. Building 832 Canyon iron filings treatment system using siphon wells, (OU7).

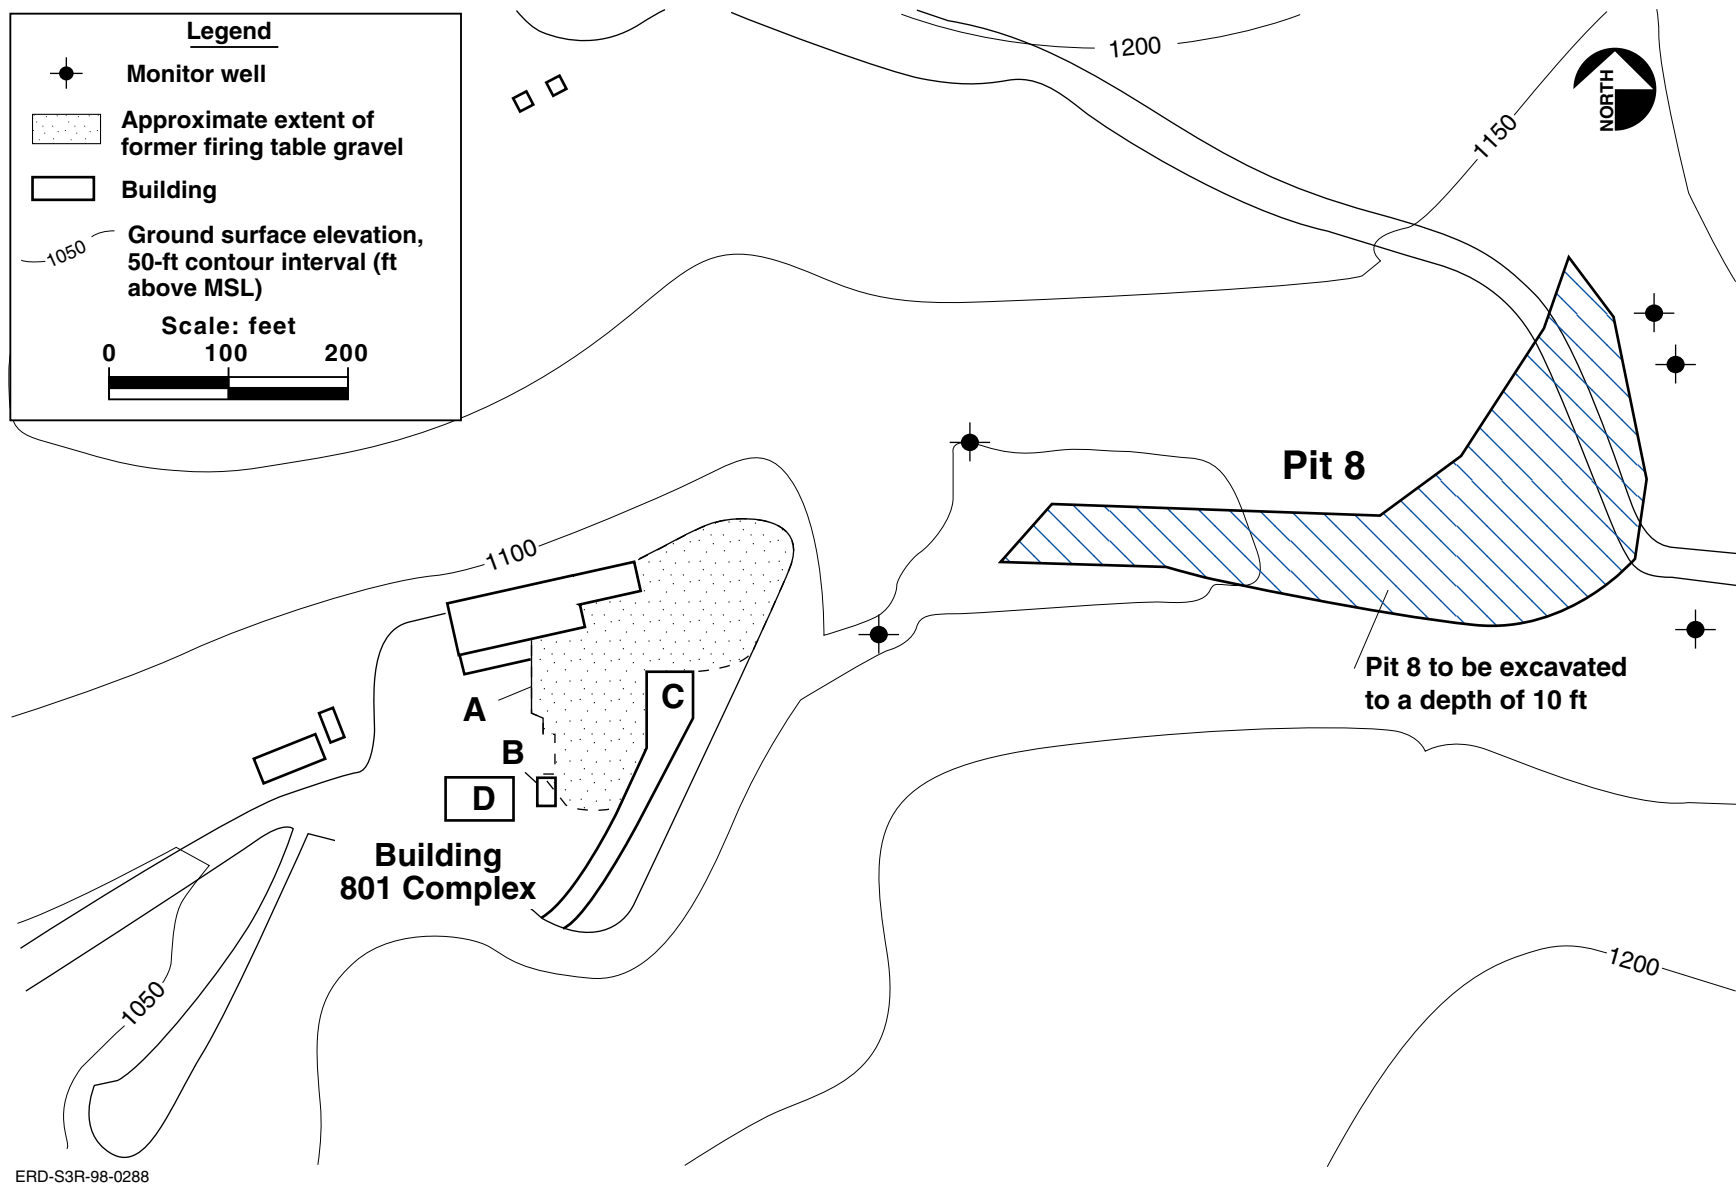
Figure 4-14. Location of contaminated soil to be excavated for the Building 801 and Landfill Pit 8 remediation modules, (OU8).

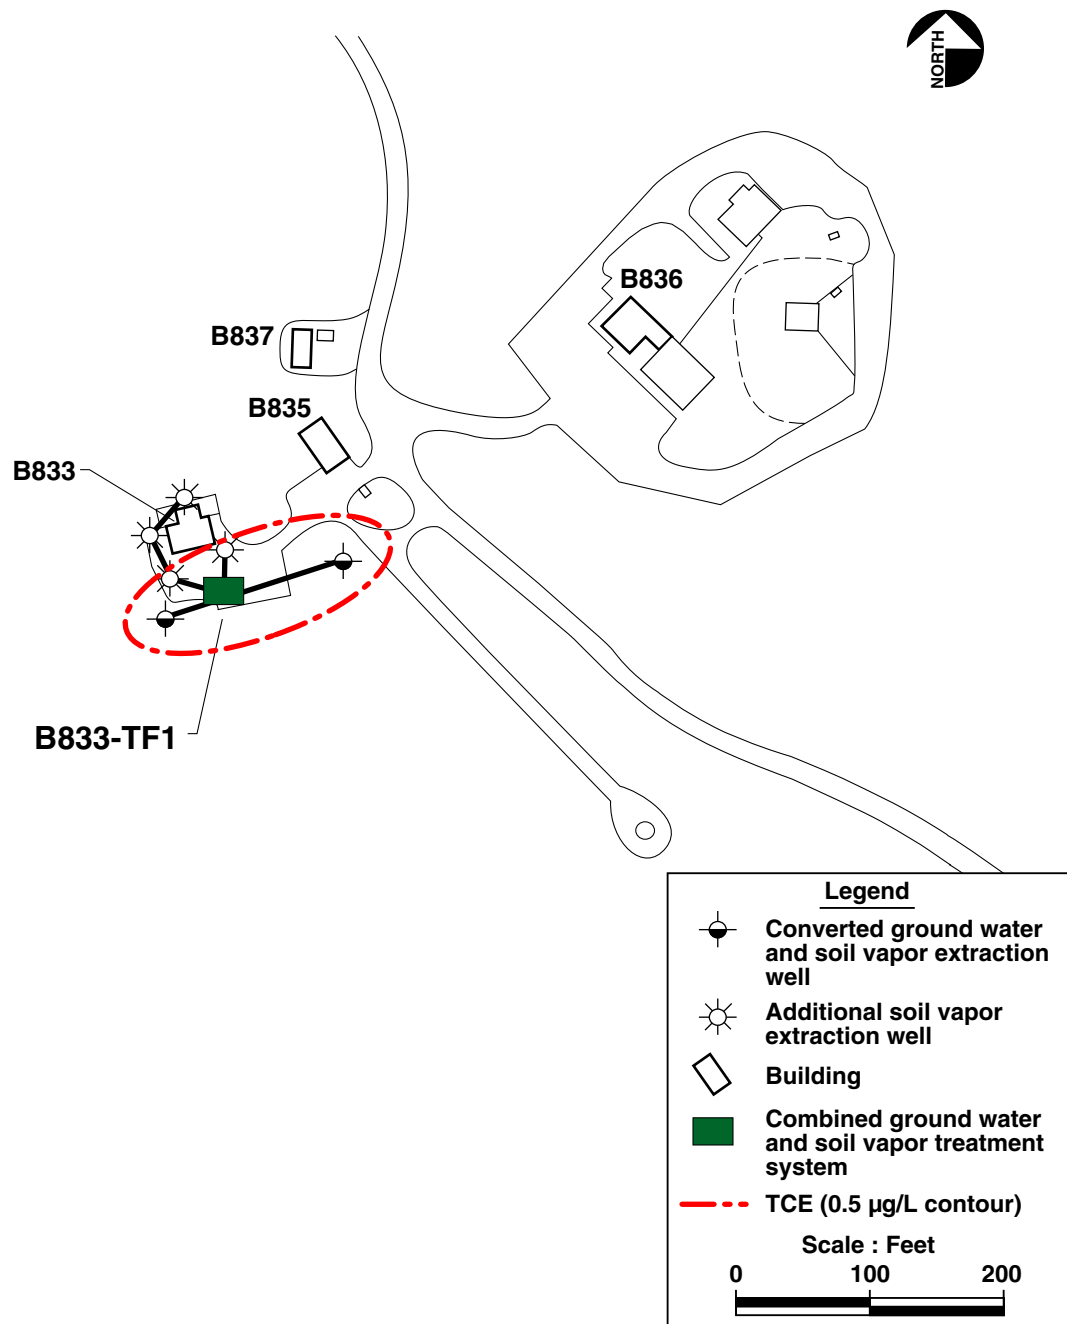
ERD-S3R-98-0223

Figure 4-15. Locations of components of the Building 833 area remediation modules, (OU8).

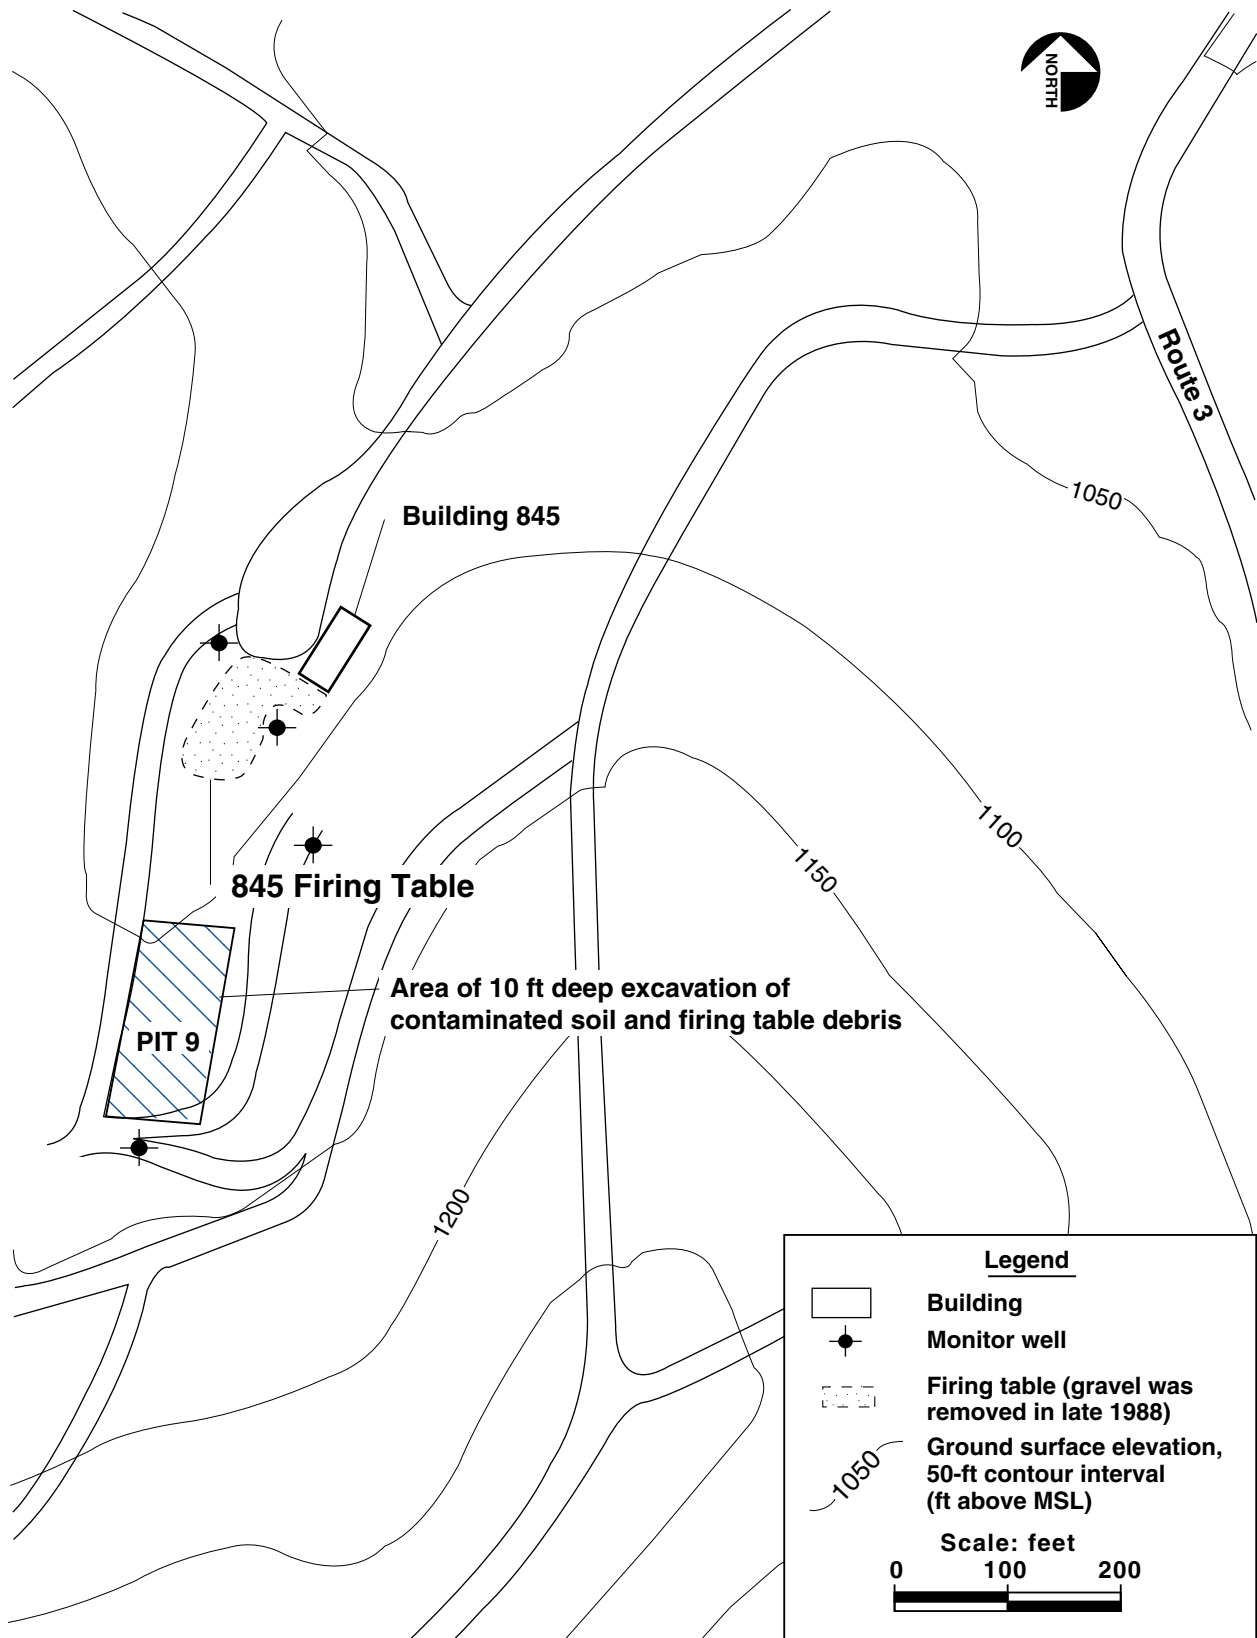
Figure 4-16. Location of contaminated soil to be excavated for the Building 845 firing table and Landfill Pit 9 remediation modules, (OU8).

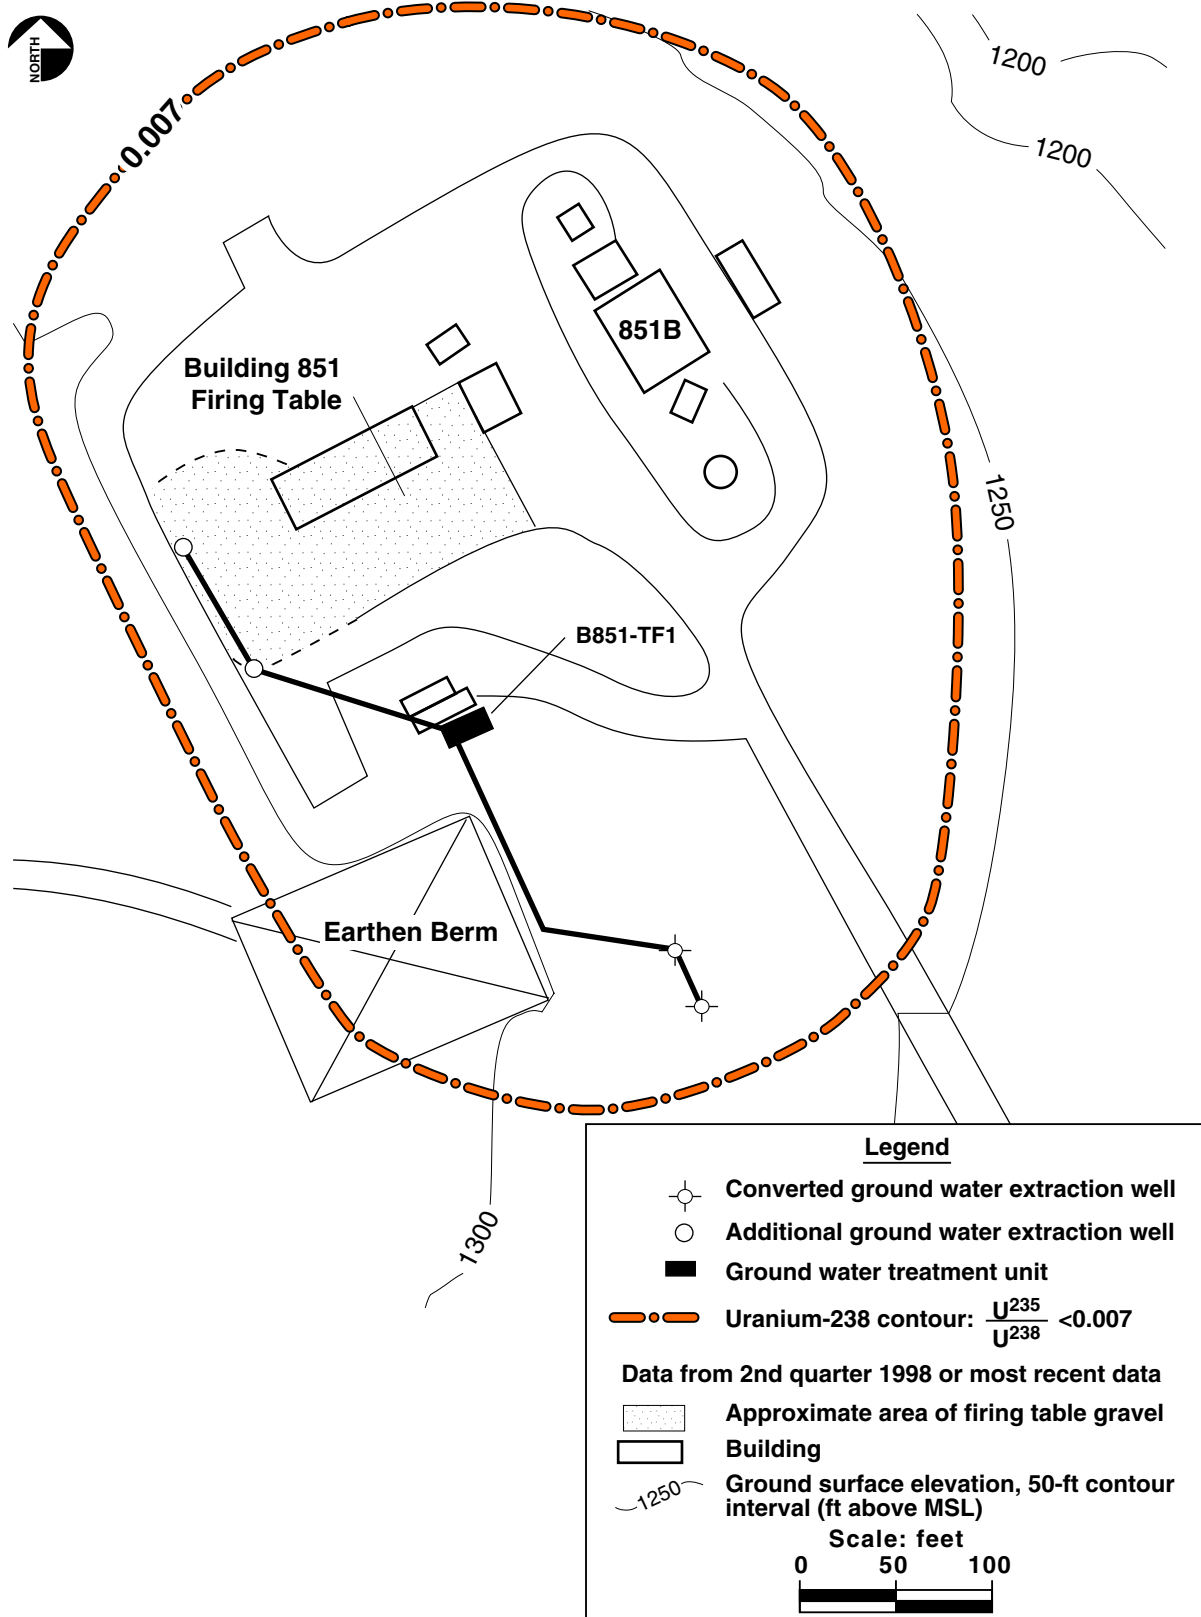
ERD-S3R-98-0264

Figure 4-17. Location of components of the Building 851 remediation module, (OU8).
